INVESTIGATION OF CRAWL SPACE VENTILATION

MOISTURE CONTROL STRATEGIES

FOR B.C. HOUSES

Final Report

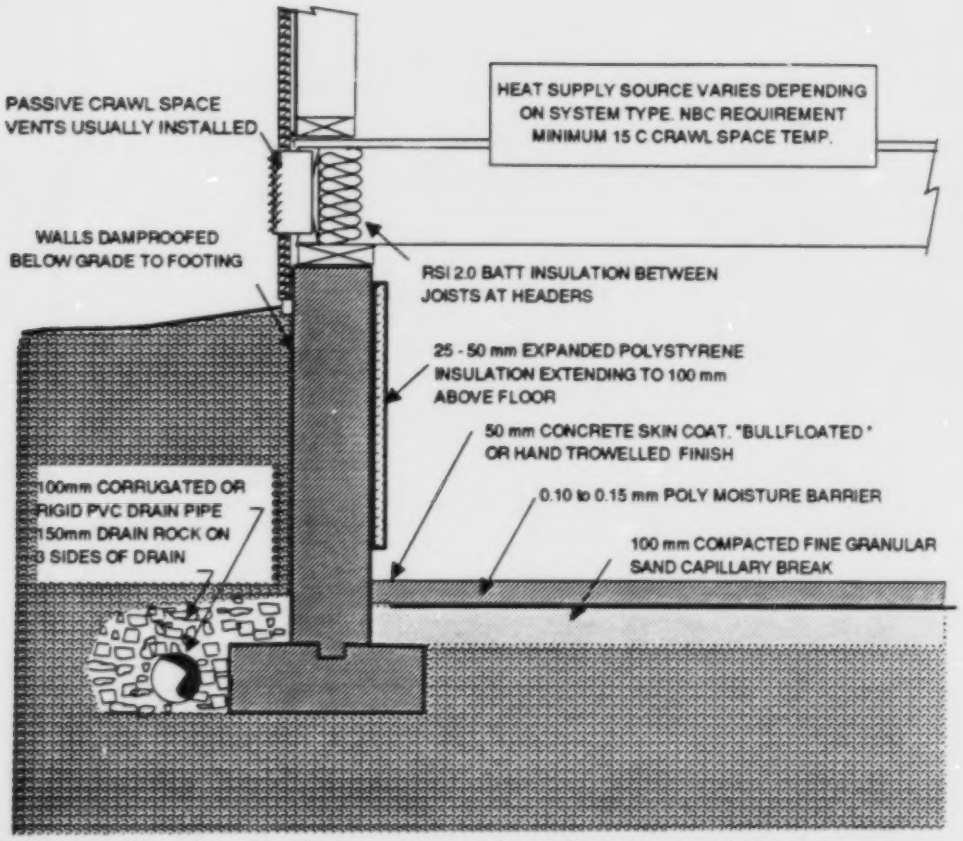
Figure 3: Typical Construction for Heated Crawl Spaces in B.C. Houses

The following discussion covers many of the general issues related to the performance of crawl space moisture control systems in B.C.. The discussion is based on case study observations and information obtained from builders, and inspectors. Figure 5 illustrates, quite realistically, the kind of problems that can occur with a poorly designed crawl space system. Figure 6 on the other hand, illustrates what an effective crawl space moisture control system should look like for a heated crawl space.

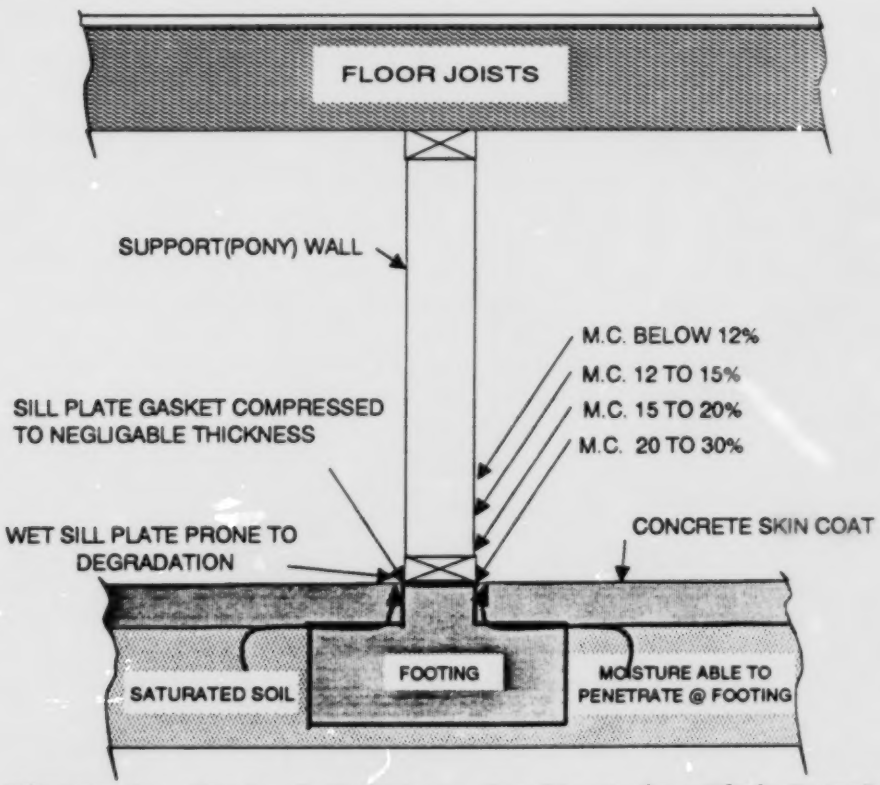
Figure 4: Typical Moisture Gradient for Slab Level Support Walls

The absence of concrete curb walls for interior support walls may cause structural damage in many houses built in this manner. Three of the houses visited had support walls built at floor level and of these, two recorded wood MC's of greater than 20 % at the sill plates. Moisture moving horizontally through the floor slab saturates the sill plates. Figure 4 illustrates the typical moisture gradient of sill plates resting on a slab located in region where the soil may be saturated.

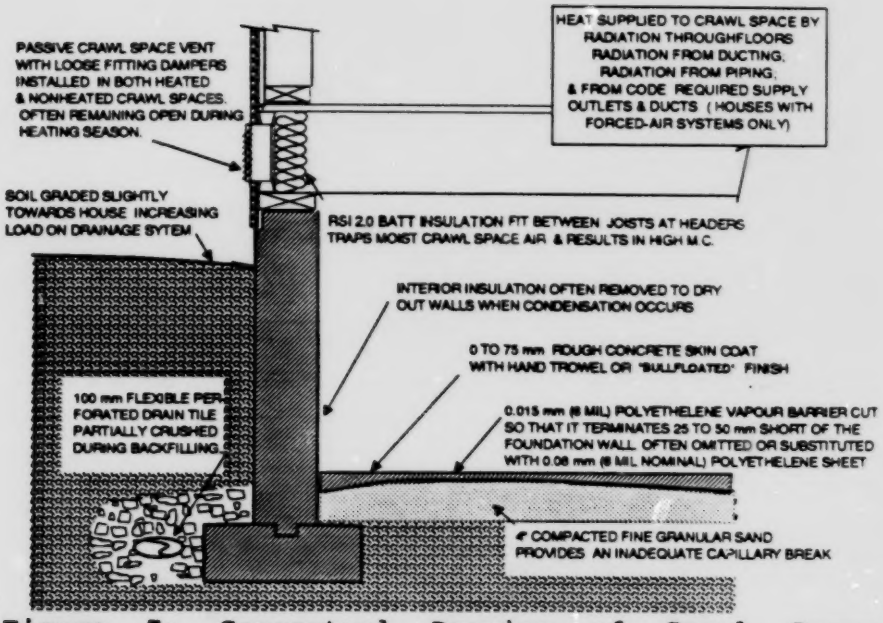
HEAT SUPPLIED TO CRAWL SPACE BY RADIATION THROUGHFLOORS RADIATION FROM DUCTING, RADIATION FROM PIPING, & FROM CODE REQUIRED SUPPLY OUTLETS & DUCTS (HOUSES WITH FORCED-AIR SYSTEMS ONLY)
PASSIVE CRAWL SPACE VENT WITH LOOSE FITTING DAMPERS INSTALLED IN BOTH HEATED & NONHEATED CRAWL SPACES. OFTEN REMAINING OPEN DURING HEATING SEASON.
SOIL GRADED SLIGHTLY TOWARDS HOUSE INCREASING LOAD ON DRAINAGE SYTEM
RSI 2.0 BATT INSULATION FIT BETWEEN JOISTS AT HEADERS TRAPS MOIST CRAWL SPACE AIR & RESULTS IN HIGH M.C.
INTERIOR INSULATION OFTEN REMOVED TO DRY OUT WALLS WHEN CONDENSATION OCCURS
0 TO 75 mm ROUGH CONCRETE SKIN COAT WITH HAND TROWEL OR "BULLFLOATED" FINISH
100 mm FLEXIBLE PERFORATED DRAIN TILE PARTIALLY CRUSHED DURING BACKFILLING

0.015 mm (6 MIL) POLYETHELENE VAPOUR BARRIER CUT SO THAT IT TERMINATES 25 TO 50 mm SHORT OF THE FOUNDATION WALL OFTEN OMITTED OR SUBSTITUTED WITH 0.08 mm (8 MIL NOMINAL) POLYETHELENE SHEET
4" COMPACTED FINE GRANULAR SAND PROVIDES AN INADEQUATE CAPILLARY BREAK

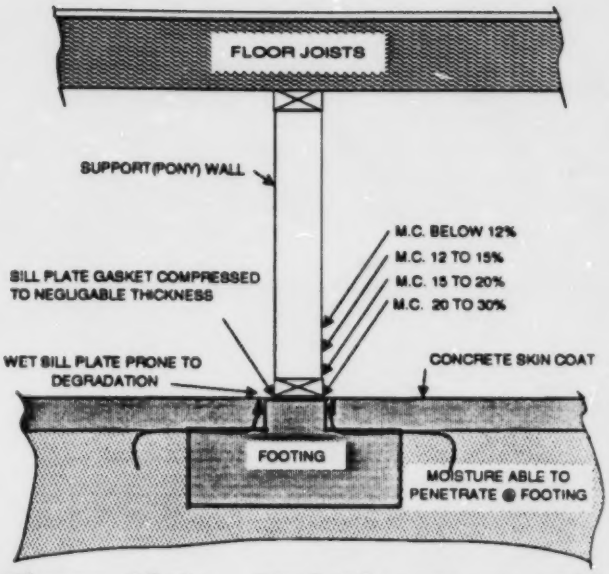
The absence of concrete curb walls for interior support walls may cause structural damage in many houses built in this manner. Three (3) of the houses visited had support walls built at floor level and in House #2 and House #10, measured wood MC's were greater than 20 % at the sill plates. These pony walls rest on a concrete footing that is flush with the floor slab. Moisture moving horizontally through the floor slab saturates the sill plates. Figure 4 shows the typical moisture gradient of sill plates resting on the slab.

Figure A2-1: Typical support wall moisture gradient.

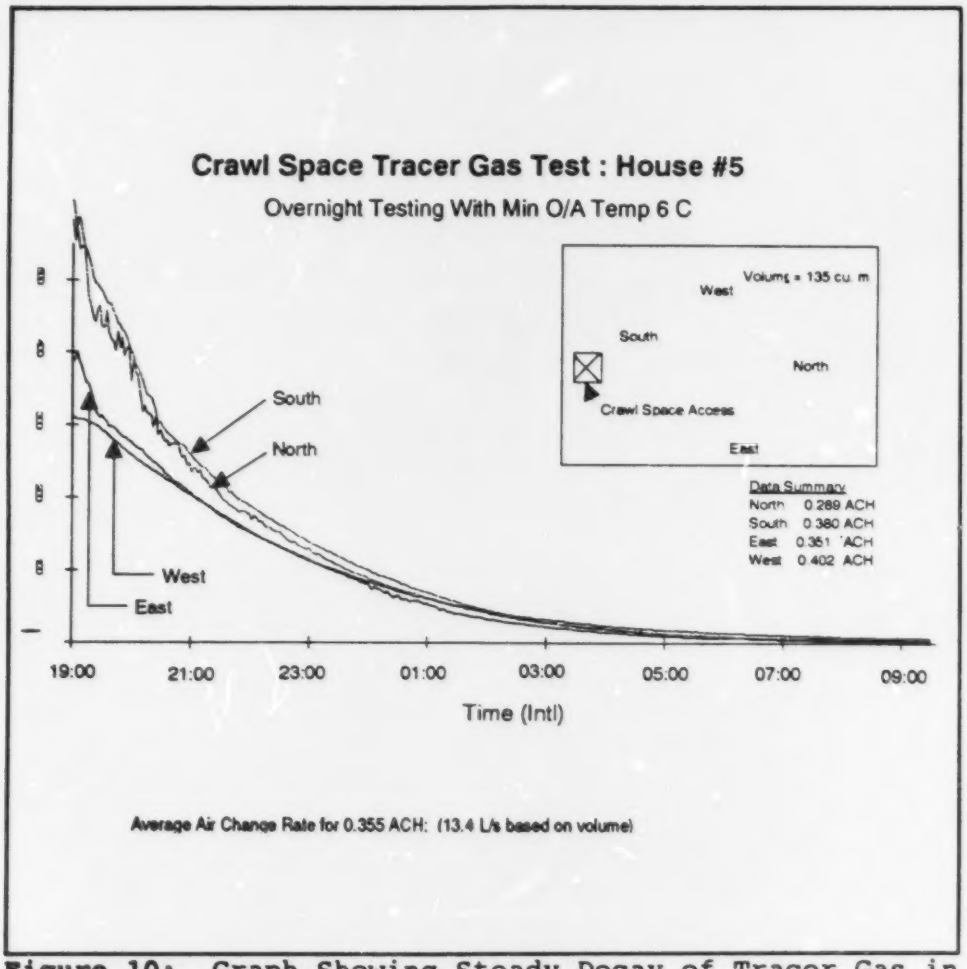
Figure 10: Graph Showing Steady Decay of Tracer Gas in House #5 Crawl Space

Tracer Gas Air Change Test: The house was initially unconditioned and the heating system was energized after initial moisture measurements were taken. When the house reached stable temperature conditions a tracer gas air change test was done. The air change test commenced in the evening and the tracer gas analyzer was left running until the next morning with an average ACH for the crawl space of 0.356. This calculates to 13.3 L/s of outdoor air entering the space through cracks and leaks driven by wind and stack pressure. The average temperature outdoors was 10 °C and in the space 18 °C. A summary of the data collected is provided below as well as a graph showing the decrease in air change rate as the distance from the crawl space hatch increases. It was observed that most of the interface leakage is in this area because of plumbing penetrations and the hatch itself.

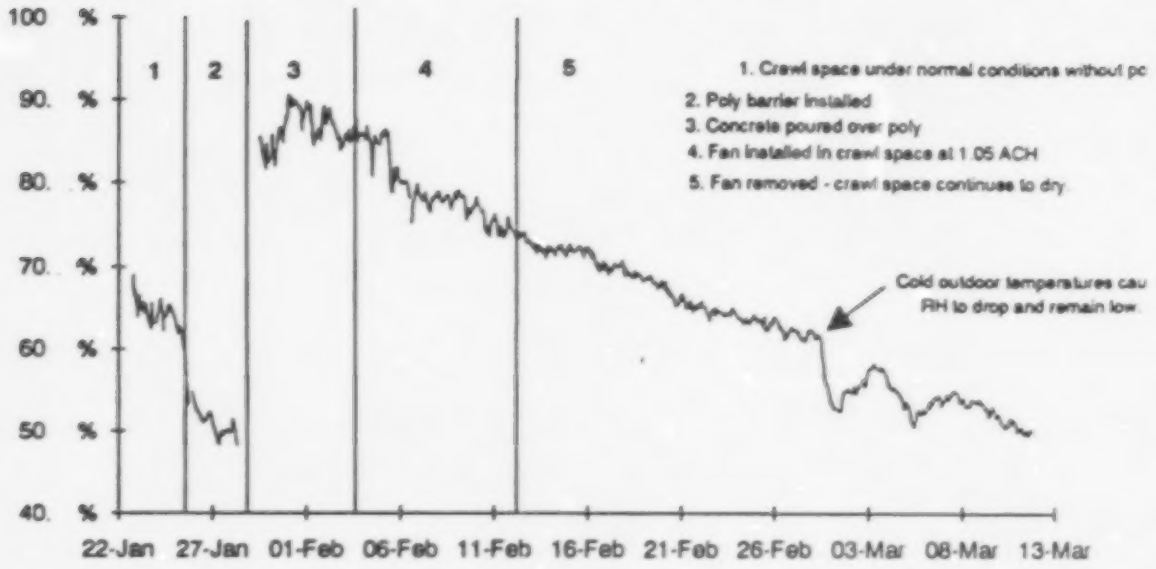
House #6 **Post-retrofit Crawl Space Relative Humidity**

After reviewing the data collected, it was seen that the moisture levels in the crawl space had stabilized at approximately 1.5 gm/kg higher than outdoors. This was a similar level that measured just prior to the placement of the new floor. This does not imply that the retrofit was not successful. The monitoring period was not long enough to give any satisfactoring conclusions about the long term effectiveness. At the time the data logger was removed, there was still considerable residual moisture in the structural members to hold the moisture at this steady level. During a cold period however, as can be seen in the graphs below, the crawl space dried out very quickly over 1 - 2 days and the levels did not rebound. Measurements of the slab MC show that the new concrete is already much drier than the original concrete MC. The following graphs & tables show the pattern of events and moisture levels over the entire monitoring period.

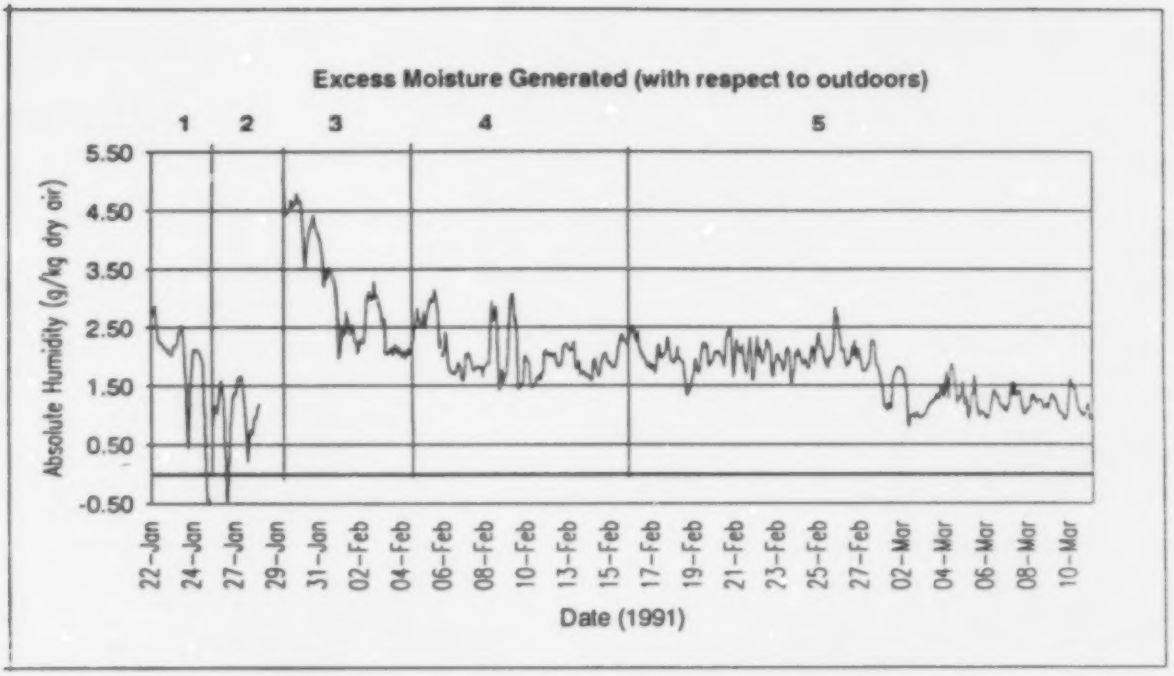
Time Table of House #6 Retrofit Activity

Period	Date	Event
1	Jan/22/91	Install monitoring equipment
2	Jan/25/91	Lay 6 mil "vapour barrier" over existing concrete skin coat
3	Jan/28/91	Pour additional 50mm concrete skin coat over poly.
4	Feb/03/91	Install fan in crawl space to force air change @ est 1.05 ACH.
5	Feb/12/91	Fan shut off ; vents dampers 1/2 closed.
6	Mar/11/91	Remove monitoring equipment.

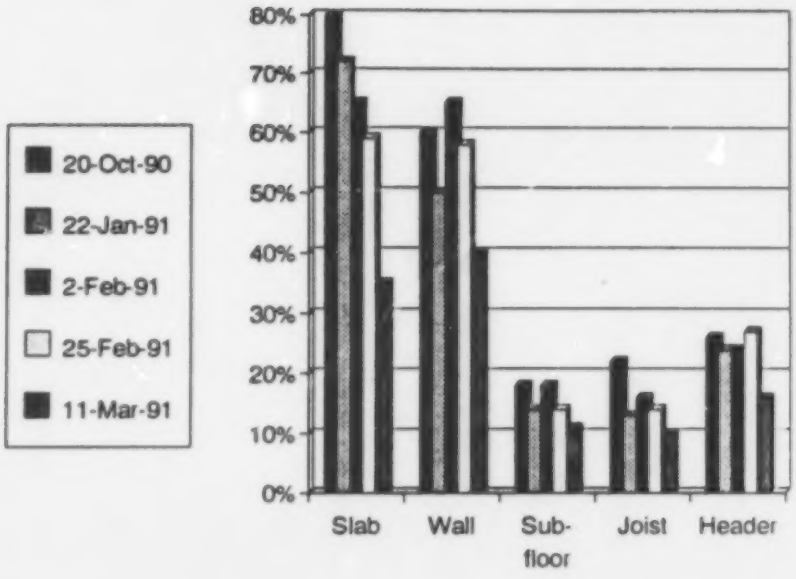
Moisture content measurements in House #6 crawl space over course of monitoring period.

Location of measurement				
	Concrete M.C.		Wood M.C.		
Date	Slab	Wall	Sub-floor	Joist	Header
20-Oct-90	80%	60%	18%	22%	26%
22-Jan-91	72%	50%	14%	13%	24%
2-Feb-91	65%	65%	18%	16%	24%
25-Feb-91	59%	58%	14%	14%	27%
11-Mar-91	35%	40%	11%	10%	16%

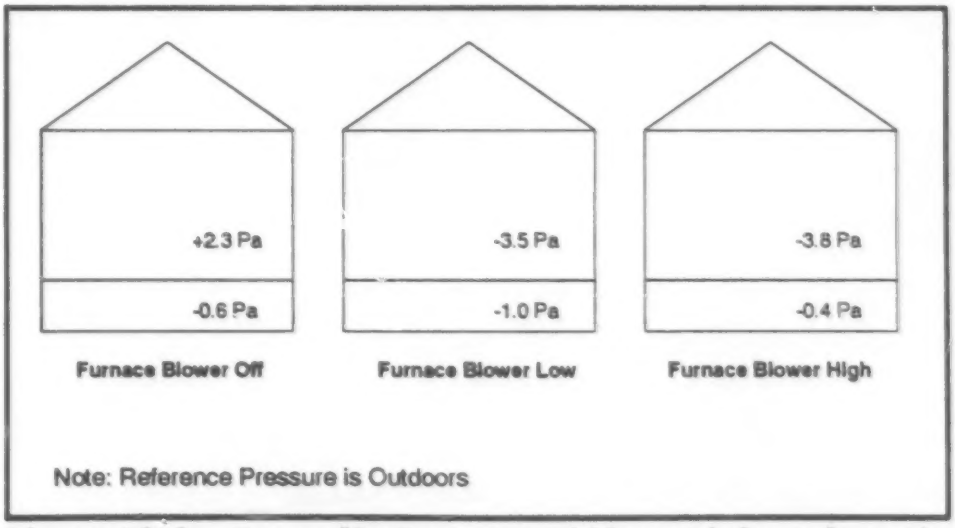
Findings and observations: The visit by researchers on January 4, 1991 revealed very high moisture levels in the crawl space and house. It would still be too early for the remedial measures to have any impact. Due to the cold weather at the time, windows throughout the house were covered in thick condensation and ice. Inspection of the crawl space revealed an extremely wet situation, with pooling and running water throughout, and heavy condensation build-up behind batts and behind the wall moisture barrier.

Figure A2-3: House #9; Pressure Differentials (after the installation of 4 crawl space vents and closing return air openings in crawl space)

It was difficult to understand the strategy that had been adapted by the contractor to resolve the moisture problem. The addition of crawl space vents would presumably assist in drying out the space. The addition of warm air supply to the crawl space may also be explained in terms of shortening the dry out period. However with open puddles around the crawl space, warmer temperatures could lead to additional humidity entering the living areas of the house. To evaluate this potential problem measurements were taken of pressure differential between the house and crawl space and outdoors. Figure 20 illustrates the pressure differentials in between these three zones, and reveals that under the normal operating condition, with the furnace blower running at low speed, the house is depressurized by over two Pascals relative to the crawl space. With the furnace blower operating at high the situation is even worse. The homeowners can expect more moisture problems indoors than before, given this situation. Advice was offered by researchers free of charge to assist in reversing the air and moisture flows. An offer was also made to develop a long term solution for their crawl space moisture problems. However the occupants decided to wait for further action from the site supervisor, or from the New Home Warranty Program if necessary. A short term solution was outlined for the residents, as follows:
